Manhole Inspection Summary

Manhole # S45II_038MH

Insp Date: **3/1/10 12:18 PM**

Location Address: **Durham st**

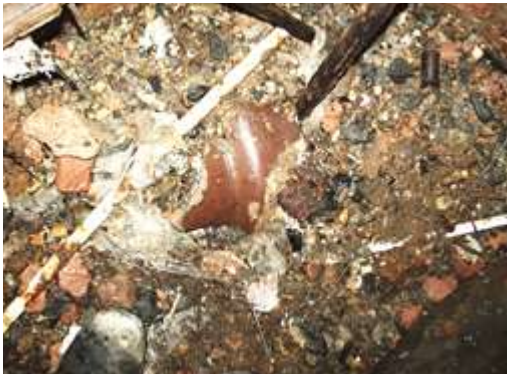
Defect 4

Condition: ☐ Sound ☐ Cracked ☐ Root Intrusion ☐ Deteriorated ☐ Leaks ☒ **Debris**

heavy debris

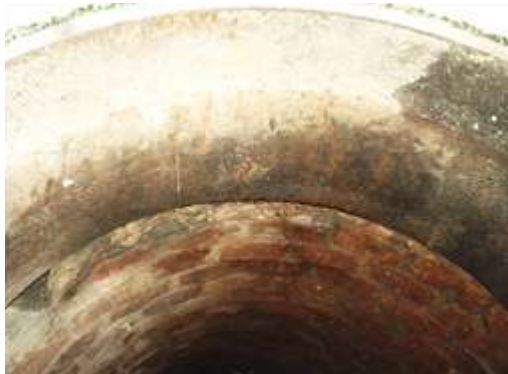
Defect 3

frame leaks

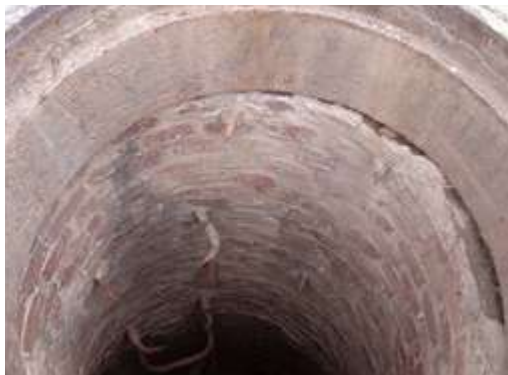
Defect 2

frame leaks

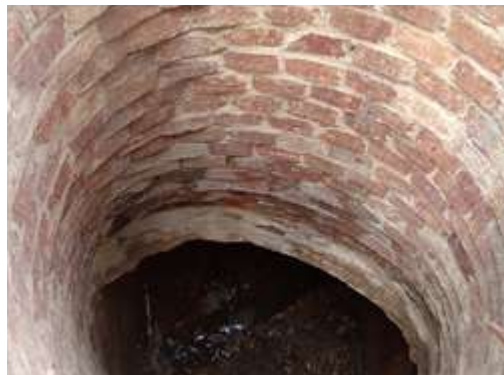
Defect 1

infiltration

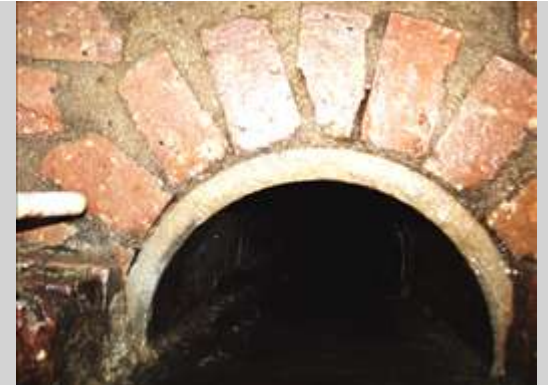
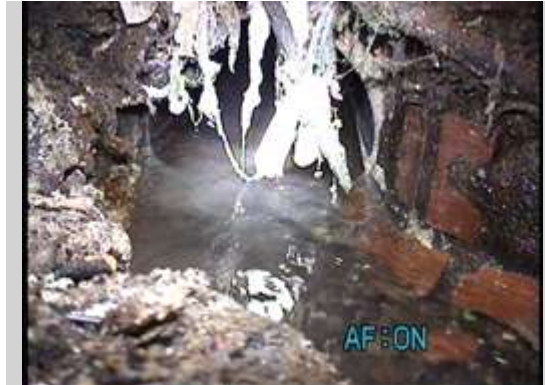
10 in. Circular Gravity Sewer
Pipe Out @ 12 O'Clock

Pipe Height: **10.8** (in.) Rod and Bar (Angled)
Pipe Material: **Clay** ☐ Pipe Lined
Invert Depth: **11.20** (ft.) Flow Characteristics: **Fast**
Deposits: ☒ None ☐ Mud ☐ Sludge ☐ Debris ☐ Grease
Silt Depth: (in.) Deposits Extent:
Infiltration: **None** Pipe Seal Cond: **Sound**

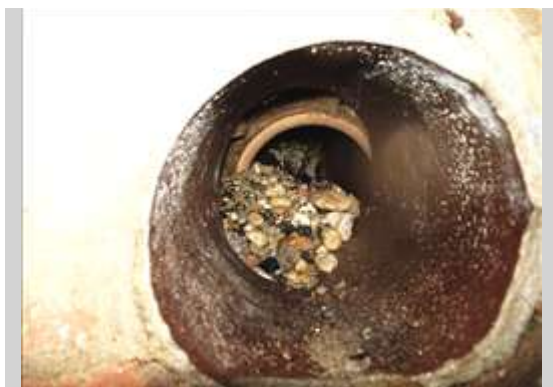
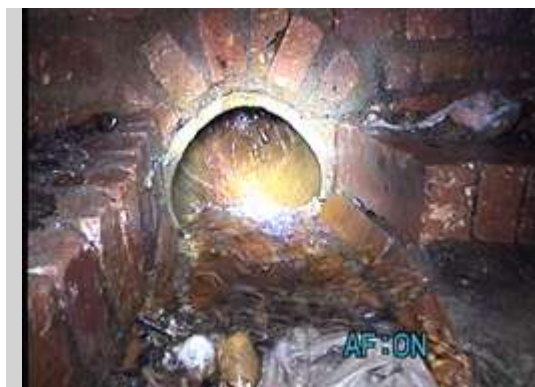
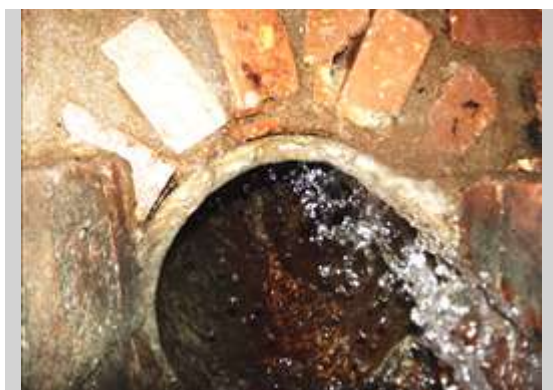
Pipe In @ 4 O'Clock

Pipe Height: 12 (in.) Rod and Bar (Angled)

Invert Depth: 8.17 (ft.) Flow Characteristics: Fast

Infiltration: None Pipe Seal Cond: Sound

Drop: Outside Rod and Bar
Angled: Yes Reading: 10.50 (ft.)
Inv Depth: 11.50 (ft.)

Drop Condition: Open

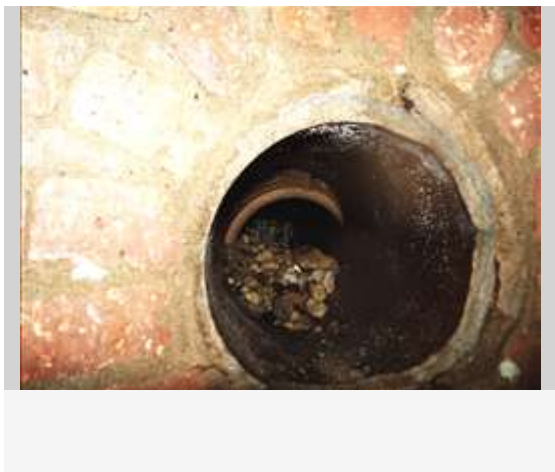
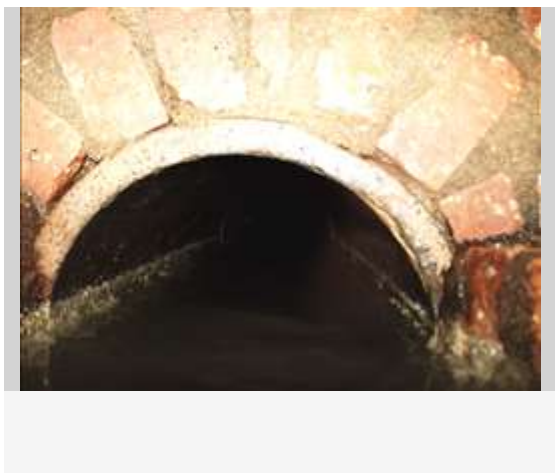
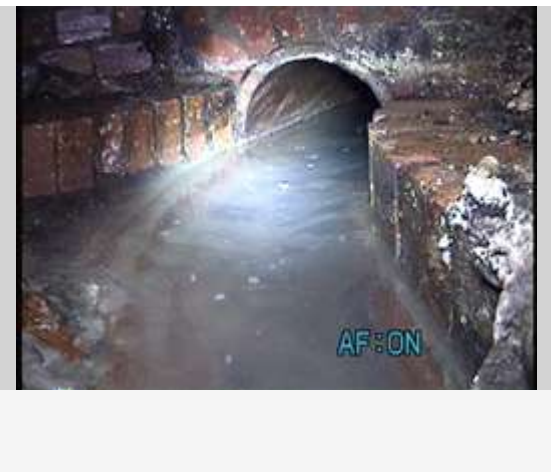
8 in. Circular Gravity Sewer
Pipe In @ 5 O'Clock

Pipe Height: **3.6** (in.) Rod and Bar (Angled)
Pipe Material: **Clay** ☐ Pipe Lined
Invert Depth: **10.25** (ft.) Flow Characteristics: **Fast**
Deposits: ☒ None ☐ Mud ☐ Sludge ☐ Debris ☐ Grease
Silt Depth: (in.) Deposits Extent:
Infiltration: **None** Pipe Seal Cond: **Sound**
